# NDE of Titanium Alloy MMC Rings for Gas Turbine Engines

# NDE OF TITANIUM ALLOY MMC RINGS FOR GAS TURBINE ENGINES

1. AGENCY USE ONLY (Leave blank)		2. REPORT DATE September 1993		3. REPORT TYPE AND DATES COVERED Technical Memorandum
4. TITLE AND SUBTITLE NDE of Titanium Alloy MMC Rings for Gas Turbine Engines			5. FUNDING NUMBERS  WU-510-01-50

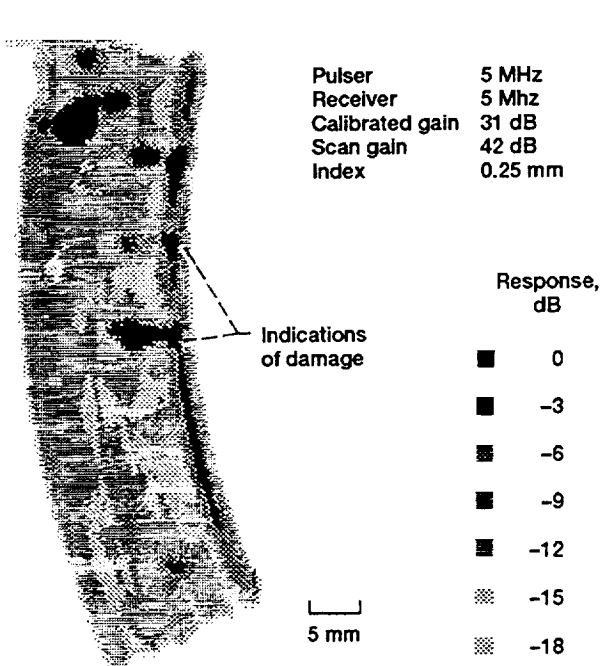
Figure 2 shows the post test ultrasonic c-scan result of a portion of the SCS-6/Alloy-C ring R4 that was static-tested to failure at 427 °C (800 °F). This ring segment, which is located approximately 180° from the burst location, contains internal damages due to the burst test. Metallography identified the "black" regions near the inner diameter of the ring in Fig. 2 as areas of damaged fibers. Figure 3 shows a metallographic cross section at a typical black region where a "notch" corresponding to ultrasonic findings guided metallographic sectioning. This cross section shows 18 damaged fibers, all located near the ID

FIGURE 2.—SELECTED SECTION OF AN ULTRASONIC P-E SCAN OF SCS-6/ALLOY-C RING R4. BLACK REGIONS INDICATE MATERIAL DAMAGE.

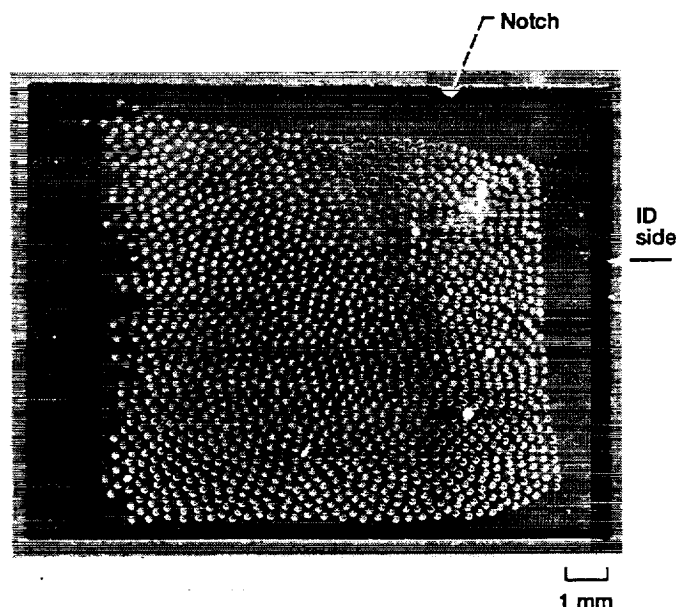
FIGURE 3.—TYPICAL METALLOGRAPHIC CROSS SECTION SHOWING FIBER DAMAGE WHERE ULTRASOUND EXHIBITED BLACK REGIONS IN RING R4. THE NOTCH WAS USED TO PINPOINT ULTRASOUND-INDICATED DAMAGE. BRIGHT WHITE FIBERS ARE THE DAMAGED FIBERS.

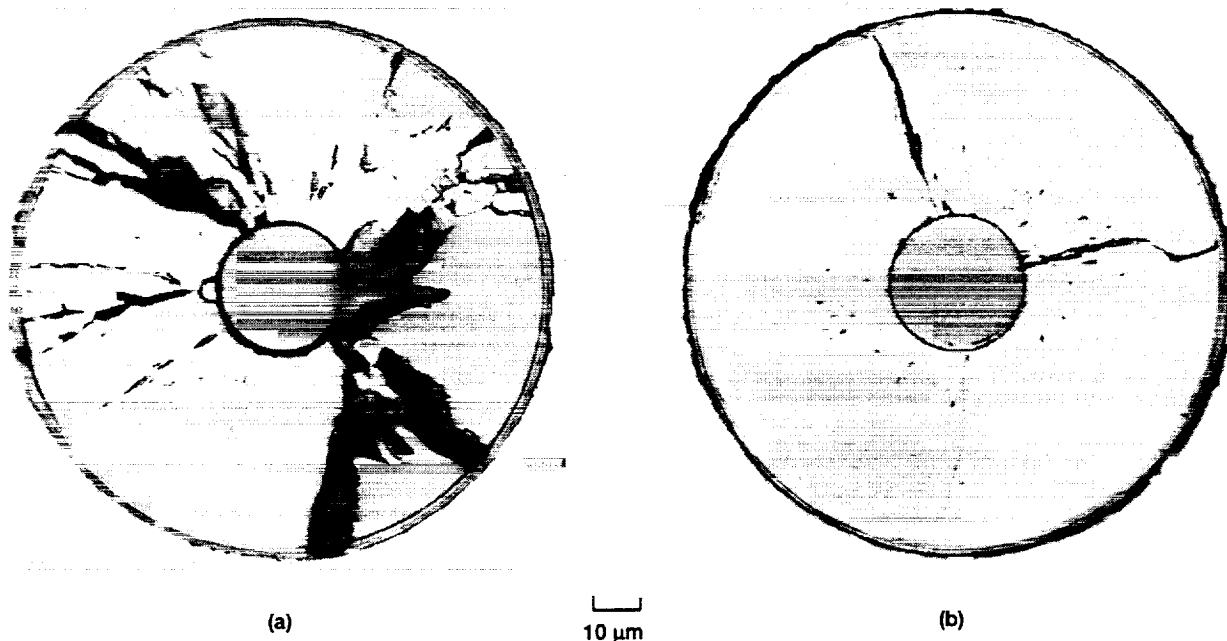
of the ring section. Higher magnifications of two of these fibers show varying degrees of damage (Fig. 4).

FIGURE 4.—PHOTOGRAPHS OF DAMAGED FIBERS FROM FIGURE 3 DEPICT (a) A CRUSHED FIBER AND (b) A CRACKED FIBER.

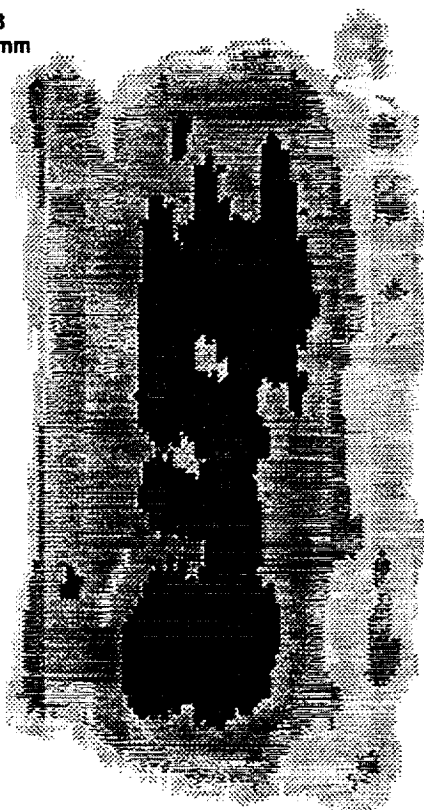
Figure 5 is an ultrasonic c-scan of a portion of ring R5. The matrix of this ring showed an increased ultrasonic response relative to other rings that were scanned at the same sensitivity before burst tests. This ring was not burst-tested. Ultrasonics, destructive testing, and metallographic sectioning revealed a great number of matrix pull-away conditions throughout the ring. Apparently, greater ultrasonic backscatter is produced by poor consolidation of the matrix material. Figure 6 is a micrograph of a polished typical area within the ring. Most of the fibers in Fig. 6 depict the matrix pull-away condition at the fiber matrix interface. Figure 7 shows higher magnification of this matrix pull-away condition. The cause of this condition has since been identified and successfully eliminated by a change in the consolidation sequence.

FIGURE 5.—SELECTED SECTION OF AN ULTRASONIC P-E SCAN OF SCS-6/ALLOY-C RING R5. BLACK REGIONS INDICATE MATERIAL DAMAGE.

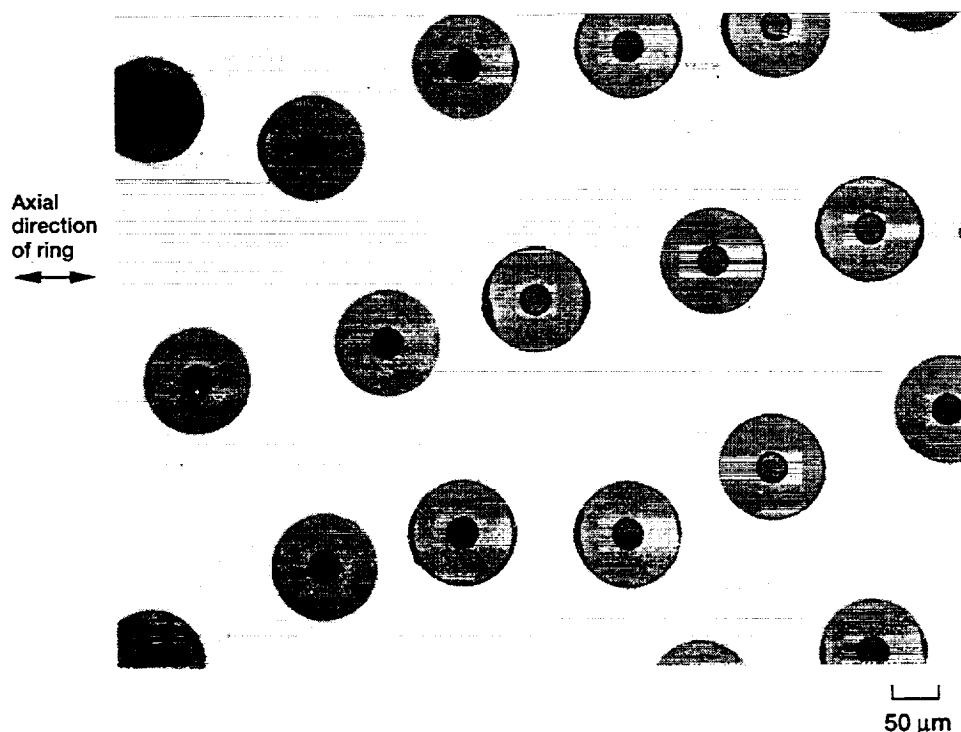
FIGURE 6.—SELECTED MICROGRAPH SHOWING MATRIX PULL-AWAY CONDITION OF MATERIAL DAMAGE CHARACTERIZED BY ULTRASOUND IN FIGURE 5.

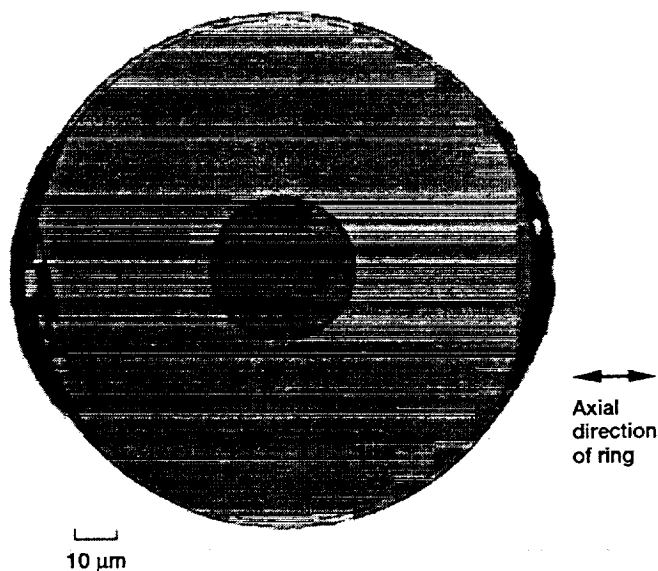
FIGURE 7.—HIGH MAGNIFICATION MICROGRAPH OF TYPICAL MATRIX PULL-AWAY CONDITION IN RING R5.

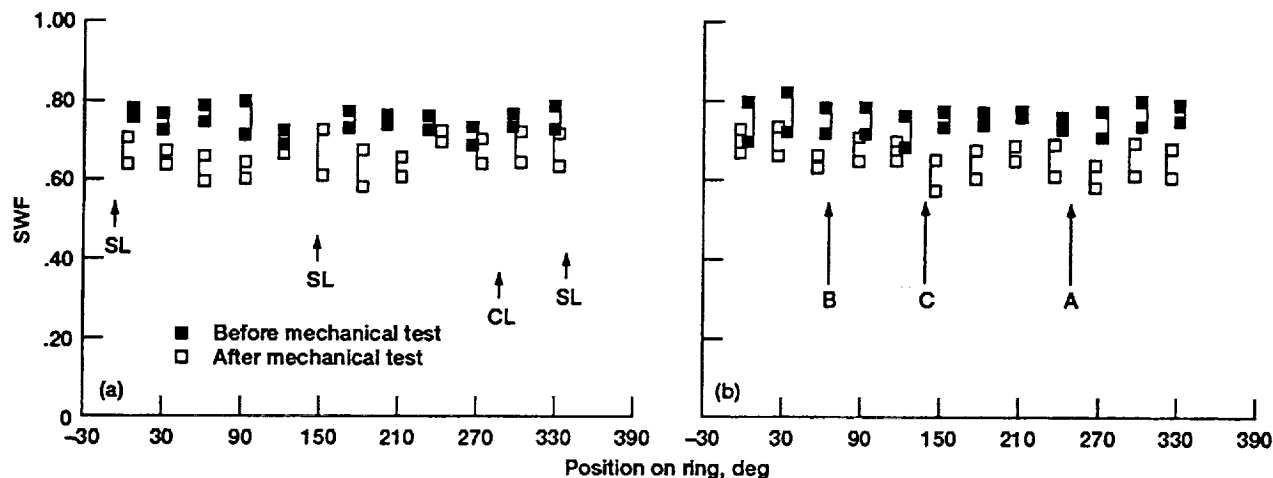
Parts (a) and (b) of Fig. 8 show the SWF's for a 5-MHz sender and 2.25-MHz receiver coupled to the outer surface of rings R1 and R3, respectively. The sender and receiver were  $\pm 10^\circ$  apart with respect to a fiducial mark. For both rings R1 and R3, the SWF was greater after the burst test. This is evidence that the burst test strained the cladding-composite interface and caused greater reflection of ultrasound back into the

cladding. This reflected energy was less attenuated going from sender to receiver, thereby giving a greater SWF.

FIGURE 8.—SWF OF THE HIGHER FREQUENCY COMPONENT OF SIGNAL IN (a) RING R1 AND (b) RING R3. (SWF = RATIO OF INTEGRATED AREA OF MAGNITUDE SPECTRUM OF [0.8 TO 3 MHz] TO THAT OF [0 TO 5 MHz]; SL = SEPARATION LOCATION; CL = CRACK LOCATION; A, B, C = ANOMALY LOCATIONS IN RADIOGRAPHS.)

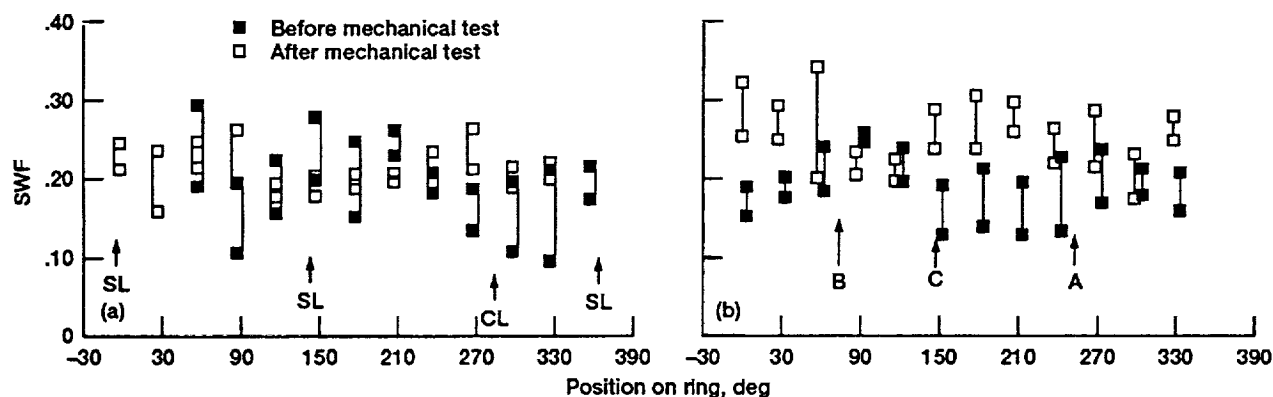
Similarly, Fig. 9 shows the SWF for only the initial portion (lower frequency) of the signals used in Fig. 8. This portion is strongly weighted by ultrasound that has passed in and out of the composite and thus does not show the increase in SWF after the burst test. Although there is more scatter in these data, Fig. 9(b) seems to indicate an actual decrease in SWF after the burst test.

FIGURE 9.—SWF OF THE LOWER FREQUENCY COMPONENT OF SIGNAL IN (a) RING R1 AND (b) RING R3. (SWF = RATIO OF INTEGRATED AREA OF MAGNITUDE SPECTRUM OF [0.2 TO 0.8 MHz] TO THAT OF [0 TO 5 MHz]; SL = SEPARATION LOCATION; CL = CRACK LOCATION; A, B, C = ANOMALY LOCATIONS IN RADIOGRAPHS.)

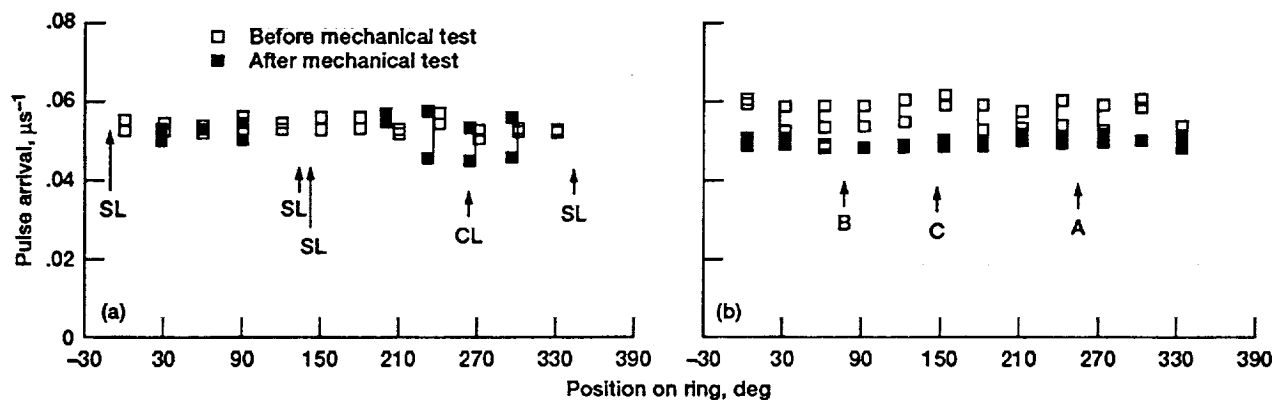
**Ultrasonic Velocity.** In earlier work (Kautz and Lerch, 1991; and Kautz, 1992), 1-MHz transducers were found to excite the first symmetric Lamb mode in SiC/Ti-15-3 MMC's. The velocity of this mode is sensitive to the axial modulus in the propagation direction. When pairs of 1-MHz transducers were coupled at  $\pm 30^\circ$  from the fiduciary position on the outer face of the rings, the collected signals were dominated by discrete pulses. Figure 10 shows estimates of the reciprocals of arrival time as a function of position on rings R1 and R3 before and after the burst test. Figure 10(a) suggests a loss of modulus along the fiber direction near the crack in the failed ring R1. Figure 10(b) demonstrates a general loss in the modulus along the fiber direction in ring R3 after the burst test.

FIGURE 10.—PULSE ARRIVAL VERSUS POSITION ALONG THE OD OF (a) RING R1 AND (b) RING R3. (SL = SEPARATION LOCATION; CL = CRACK LOCATION; A, B, C = ANOMALY LOCATIONS IN RADIOGRAPHS.)

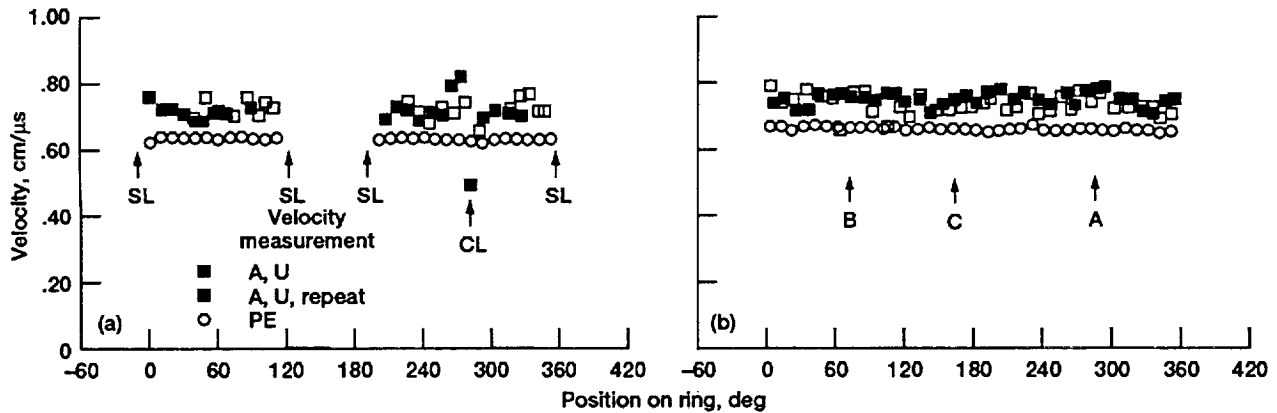
Figure 11 shows results obtained with 1-MHz transducers, but only after the burst test. These data were collected on the flat face of the rings. For these, it was possible to calculate velocity. The magnitude of these velocities is in the range 0.6 to 0.8 cm/ $\mu$ s, as would be expected for the first symmetric Lamb mode mentioned previously. Figure 11 also includes the 10-MHz pulse-echo results. All the velocities in Fig. 11(a) exhibit degradation in the vicinity of the crack in ring R1 as noted also with Fig. 10.

Velocities in ring R3 (Figs. 10(b) and 11(b)) do not show sensitivity to anomalies A, B, or C that were found with radiography to be low density regions.

FIGURE 11.—VELOCITIES IN (a) RING R1 AND (b) RING R3. (SL = SEPARATION LOCATION; CL = CRACK LOCATION; A, B, C = ANOMALY LOCATIONS IN RADIOGRAPHS.)

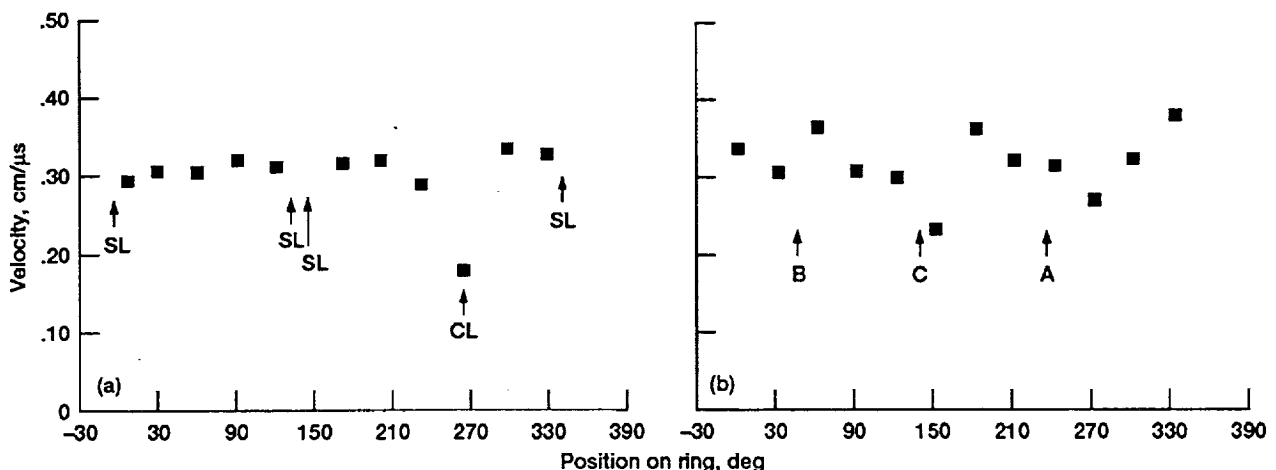
tive to shear and flexure stiffness in the propagation direction. Figure 12 shows velocities from pairs of 0.5-MHz transducers coupled to the flat sides of the rings. These velocities ranged from 0.3 to 0.4 cm/μs. This supports the assumption that these are shear wave velocities. Figure 12(a) indicates degradation of the shear velocity in the vicinity of the crack in ring R1. Unlike the axial cases, Fig. 12(b) suggests some degradation in the shear velocity in the vicinity of anomalies A, B, and C that were identified by radiography.

FIGURE 12.—SHEAR VELOCITIES FOR (a) RING R1 AND (b) RING R3. (SL = SEPARATION LOCATION; CL = CRACK LOCATION; A, B, C = ANOMALY LOCATIONS IN RADIOGRAPHS.)

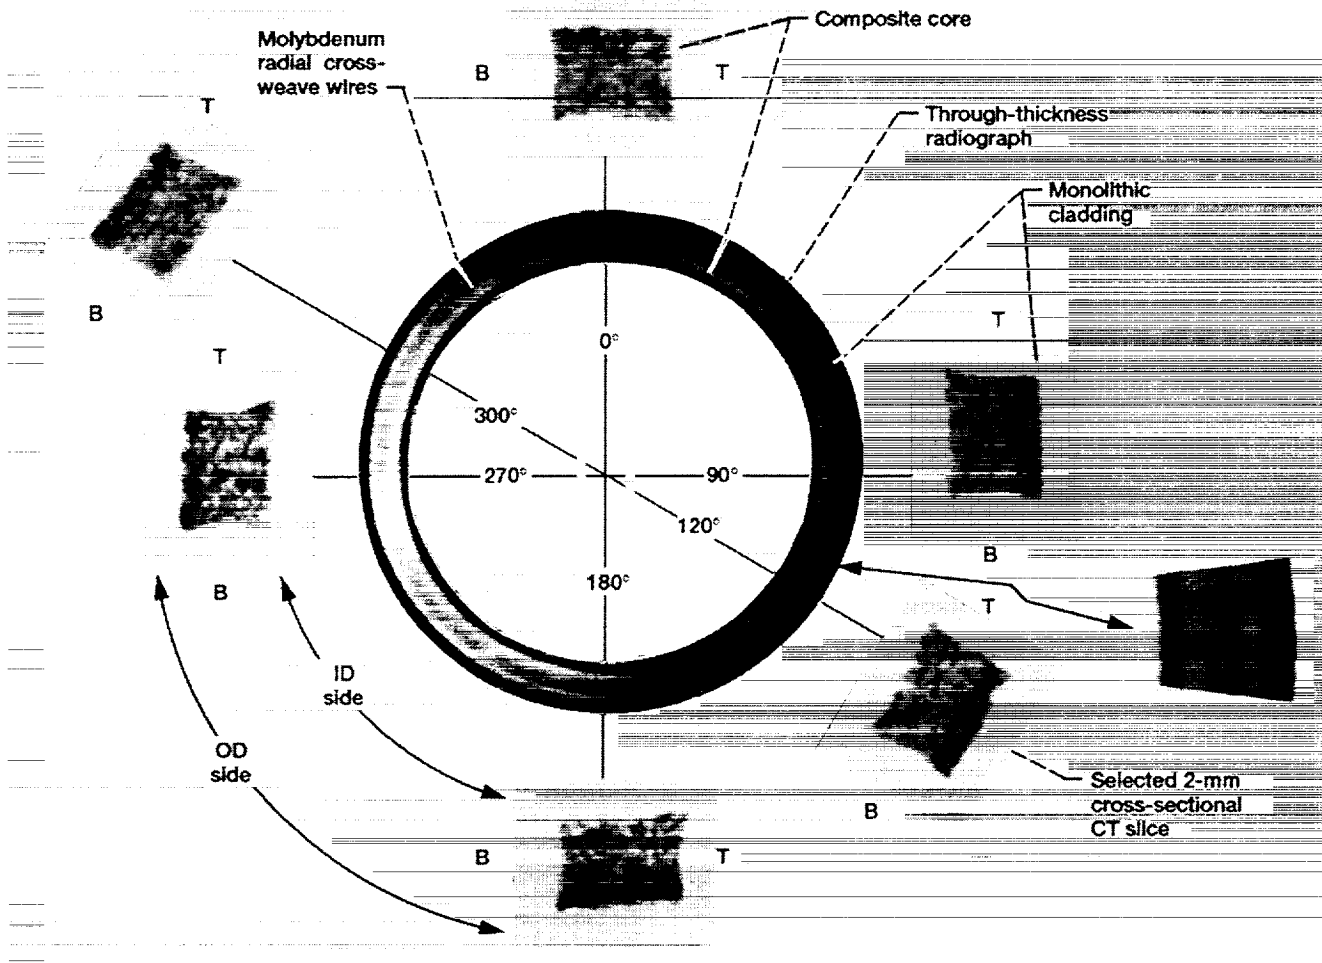
Figures 13 and 14 show through-the-thickness conventional radiographs of rings R2 and R3 along with selected XCT slices. Conventional radiography showed a thinner cladding toward the ID of ring R2 than toward the OD. Similarly, the four XCT slices not only show a smaller cladding on the ID side than on the OD side, but also detail the density variations within each slice. Conventional radiography also shows the density variations within the composite core and features the presence of sizeable low density anomalies such as the one highlighted in Fig. 13 before the 120° marker.

The XCT slices in Figs. 13 and 14 depict the presence of a protruding cusp in the core, located near the top side and toward the ID of the ring. XCT slices further demonstrated a lower fiber volume fraction and/or poorer consolidation in the core area toward the OD side than is seen toward the ID side. The core of the composite was supposed to be rectangular, uniform, and surrounded by uniform cladding.

FIGURE 13.—RADIOGRAPHY AND X-RAY COMPUTED TOMOGRAPHY OF RING R2. (ANNULUS DIMENSIONS: OD, 171 MM; ID, 133 MM; THICKNESS, 24 MM; ANNULUS MATERIALS, SCS-6/TI-15V-3CR-3AL-3SN. T IS TOP SIDE; B IS BOTTOM SIDE.) LIGHTER REGIONS INDICATE HIGHER DENSITY IN TOMOGRAPHY (DARKER IN RADIOGRAPHY).

through fibers, as in the case of the protruding cusp in all rings. The manufacturer now uses XCT images to guide machining of components to final dimensions.

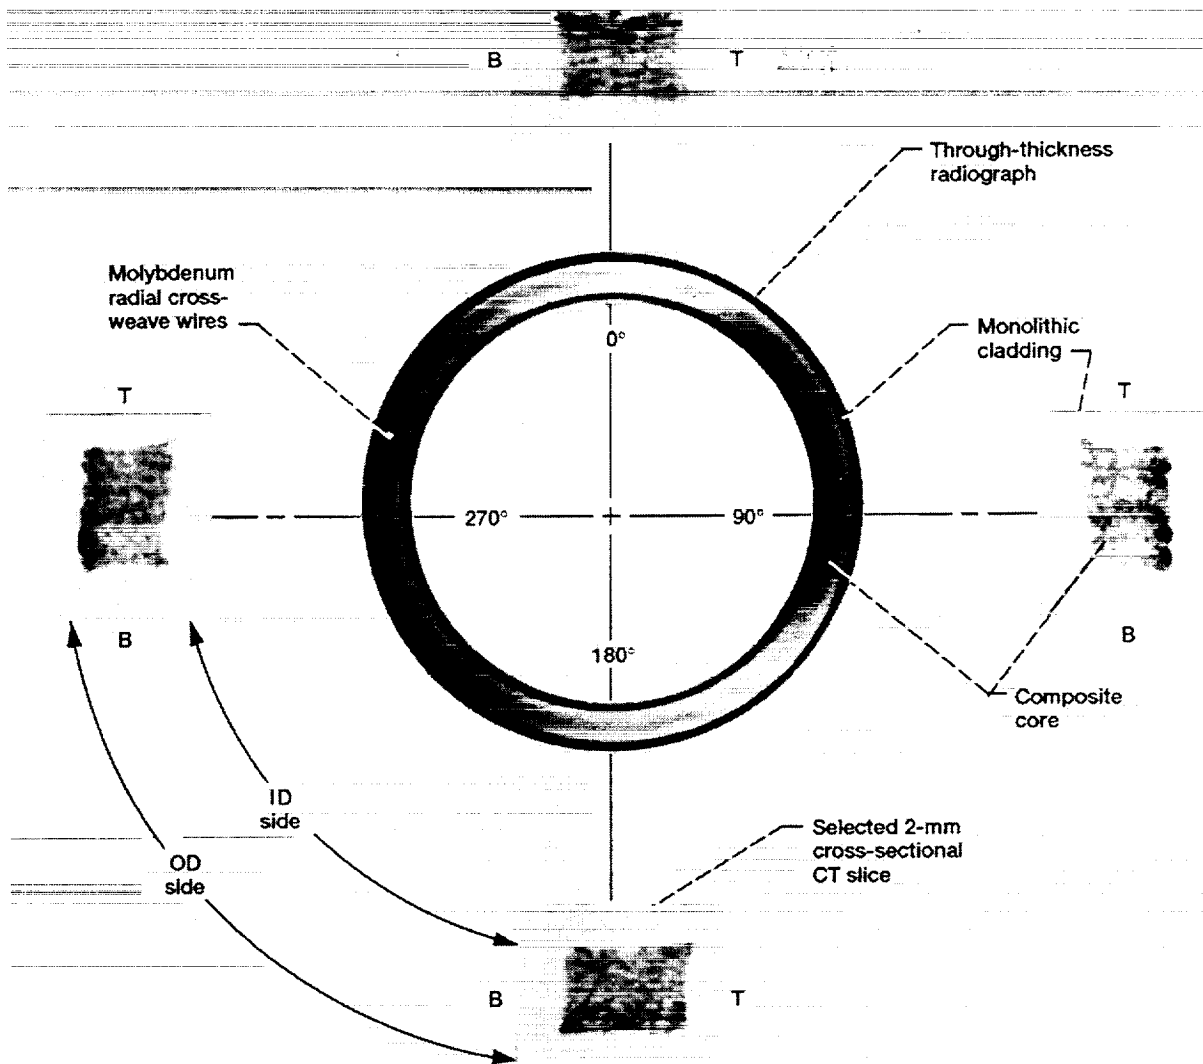
FIGURE 14.—RADIOGRAPHY AND X-RAY COMPUTED TOMOGRAPHY OF RING R3. (ANNULUS DIMENSIONS: OD, 171 MM; ID, 133 MM; THICKNESS, 24 MM. ANNULUS MATERIALS, SCS-6/TI-15V-3CR-3AL-3SN. T IS TOP SIDE; B IS BOTTOM SIDE.) LIGHTER REGIONS INDICATE HIGHER DENSITY IN TOMOGRAPHY (DARKER IN RADIOGRAPHY).

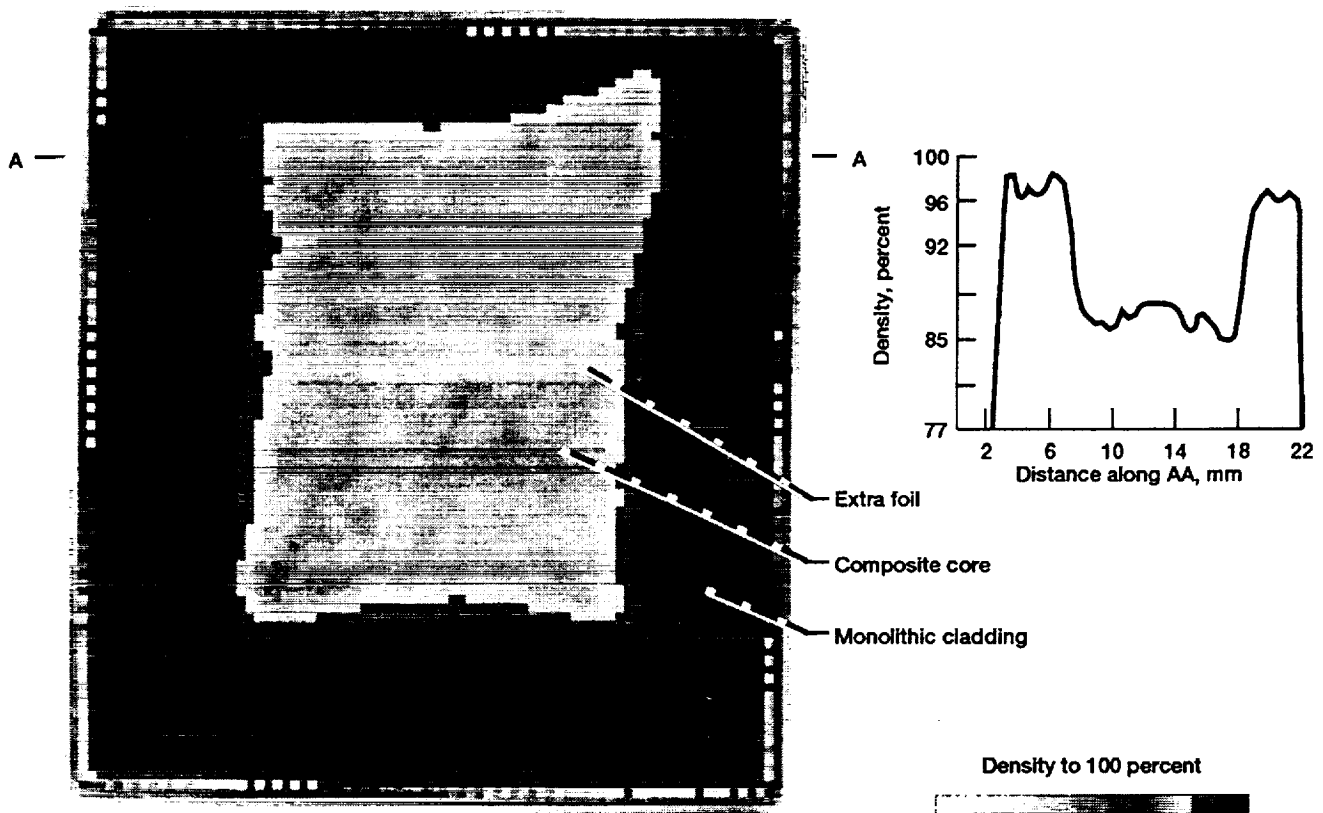
A magnified XCT image in Fig. 15 shows density variations in a slice of ring R1 before testing. The density variations along line AA show a 10-percent change between the case and the core of the ring and a 3-percent change within the composite core. Figure 15 reveals the processing/consolidation problems that resulted in the protruding cusp seen previously in rings R2 and R3. The horizontal white band in the core section indicates a manufacturing flaw (i.e., an extra foil layer).

FIGURE 15.—SELECTED XCT CROSS-SECTION FROM RING R1 SHOWING DENSITY VARIATIONS.

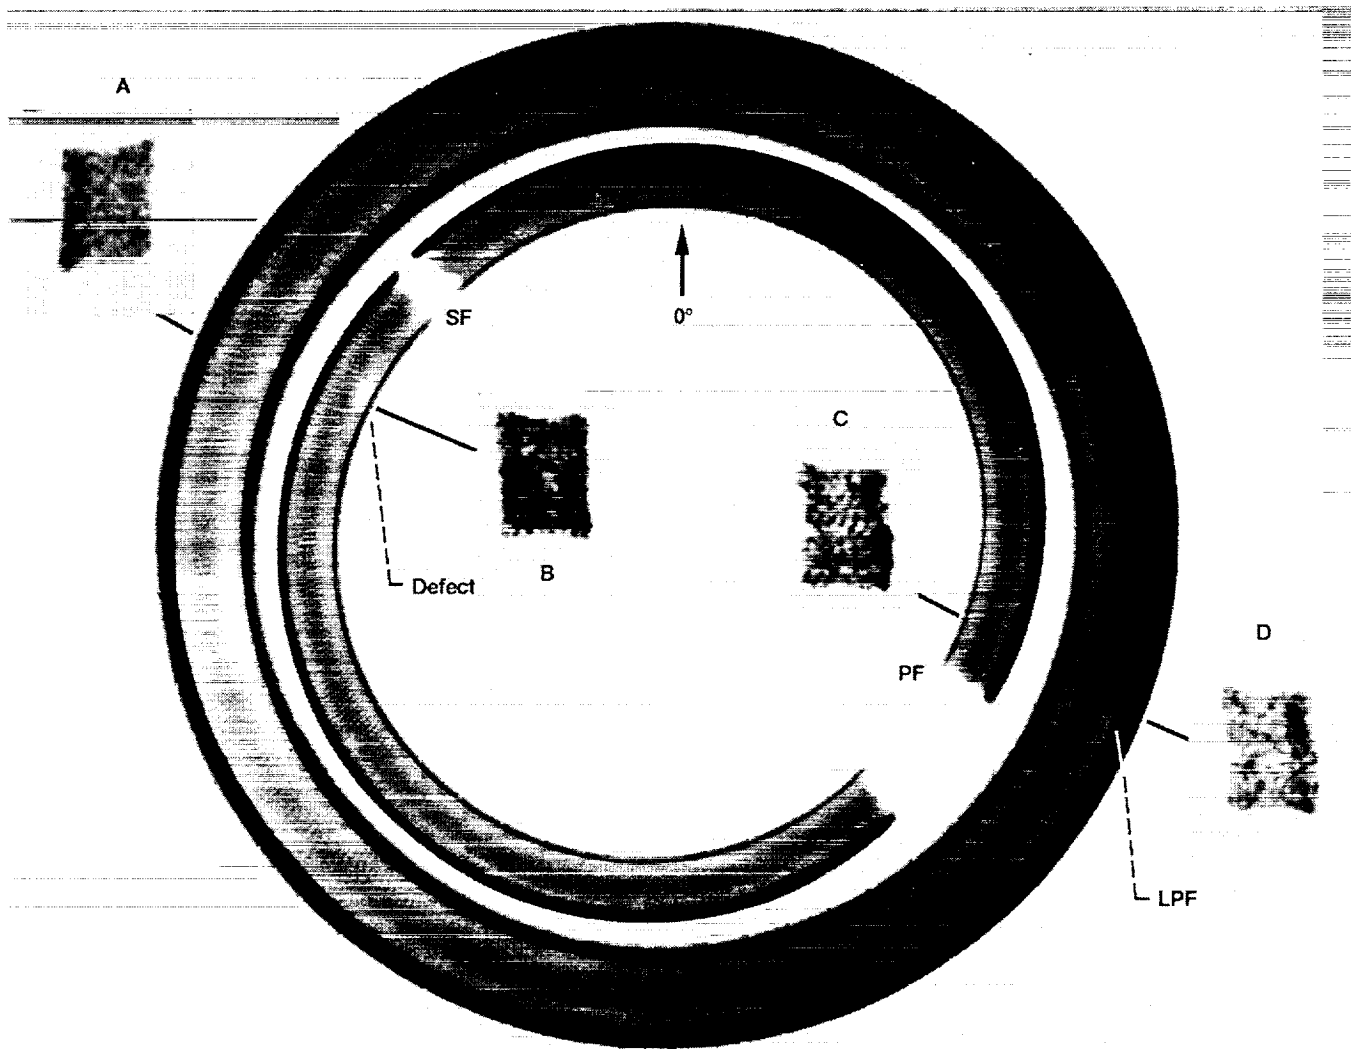
Figure 16 presents radiographs with different magnifications of R2 before and after the burst test in order to compare results on the same figure. XCT slices taken before (A and D) and after (B and C) the burst test at approximately the same locations are

also shown in Fig. 16. One location was near the burst area (i.e., the primary fracture (PF) area), and the other was near the secondary fracture (SF) area that is diametrically opposite the PF. Radiography of ring R2 before testing detected a defect condition that may have lead to the primary failure, because the location of that defect coincides with the location of the primary fracture designated LPF in Fig. 16. The defect has a low radiographic density that may indicate poor consolidation in the composite core and poor cladding-composite interface bonding. Radiography also showed poor consolidation and/or higher fiber volume fraction in the OD side of the core before and after testing. A defect appears in the radiograph taken after testing. This type of defect was also found with ultrasonics. Characterizing the defects, the difference in the degree of damage that is seen between XCT slices B and C, and the damage evolution that is seen between slices A and B and between C and D requires further work. Future work will correlate NDE findings and detailed metallographic characterization.

FIGURE 16.—RADIOGRAPHY AND SELECTED X-RAY TOMOGRAPHIC SLICES OF RING R2 BEFORE (OUTER RING) AND AFTER (INNER RING) BURST TEST. SLICES A AND D WERE TAKEN BEFORE BURST TESTING; SLICES B AND C, AFTERWARD. (PF = PRIMARY FRACTURE; SF = SECONDARY FRACTURE; LPF = LOCATION OF PRIMARY FRACTURE.) LIGHTER REGIONS INDICATE HIGHER DENSITY IN TOMOGRAPHY (DARKER IN RADIOGRAPHY).
